## IP Office Technical Tip

Tip Number: 258

Release Date: 12 December 2013

### **Unified Communications Module reverts to “write protect” mode causing Preferred Edition Voicemail to shut down**

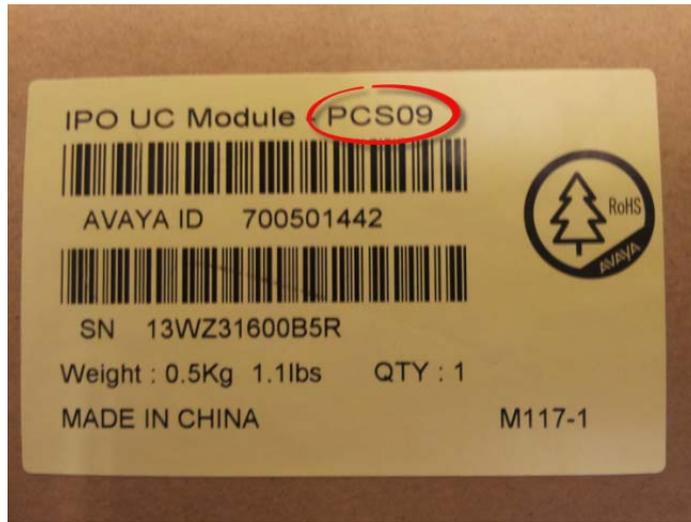
Figure 1

Also, modules exhibiting this issue will have PCS level 9 and PCS level 4 for the on-board SSD. The PCS level for the UCM can be located on either the UCM shipping box (see figure 1) or on the UCM itself (see figure 2). The PCS for the on-board SSD is located on the top right of the blue sticker that is attached to the drive (see figure 3).

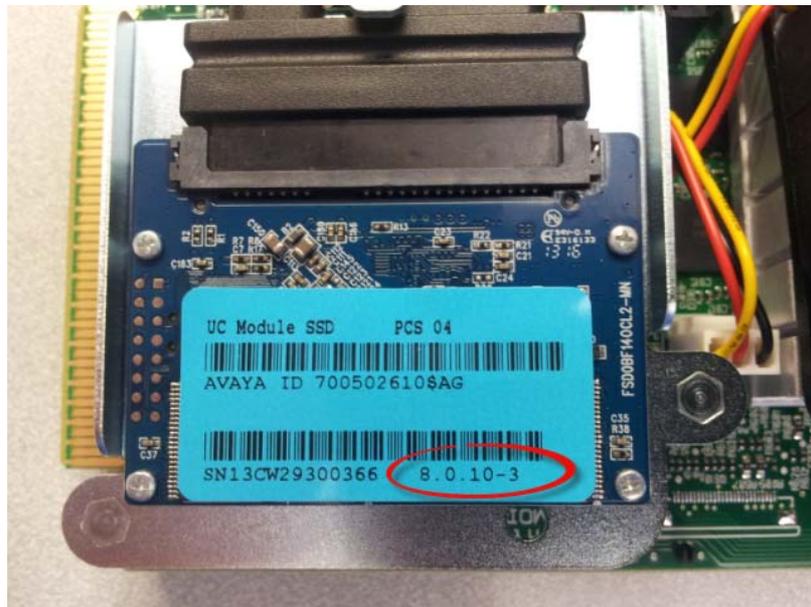
Figure 4

The level of software that is pre-loaded on the UCM is identified by the light blue sticker that is placed on top of the SSD drive. In the example below the UCM is running release 8.0.10-3 of software (figure 4):

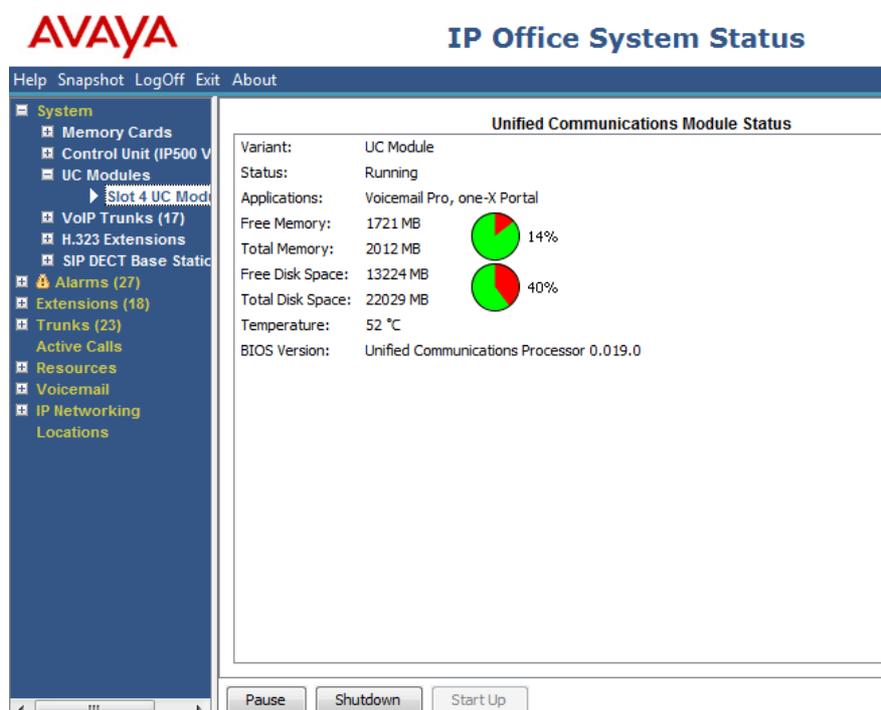
Figure 6

Once the UCM has completed the start-up process the diagnostic information will be displayed in the SSA (see figure 6):

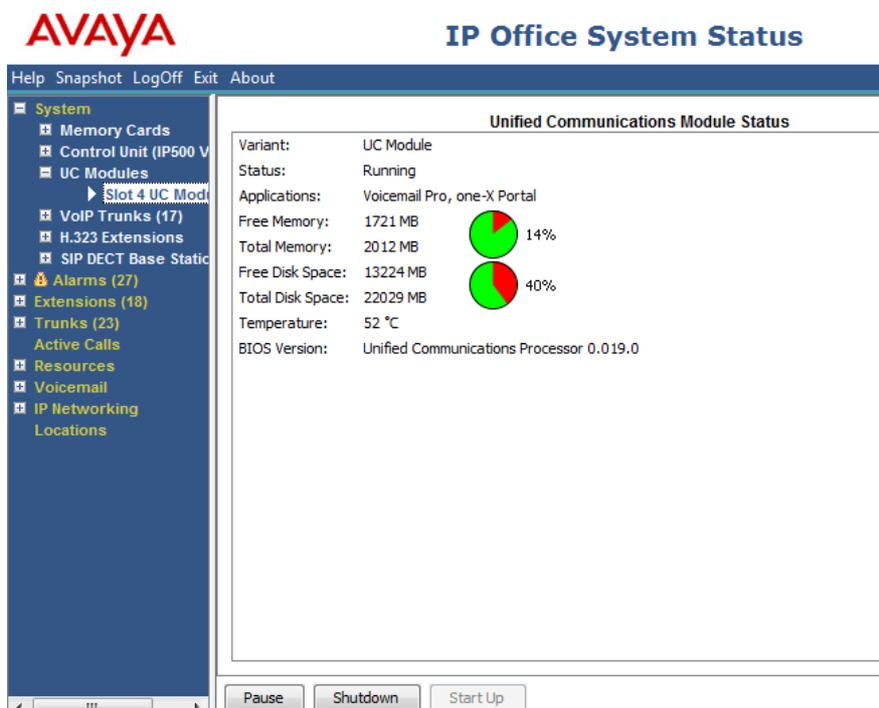
Figure 8

Once the UCM has completed the start-up process the diagnostic information will be displayed in the System Status Application (SSA) (see figure 8).
