IP Office Technical Bulletin

Bulletin No: 167
Release Date: 19 May 2014
Region: Global

General Availability (GA) - IP Office Release 9.0 Service Pack 3

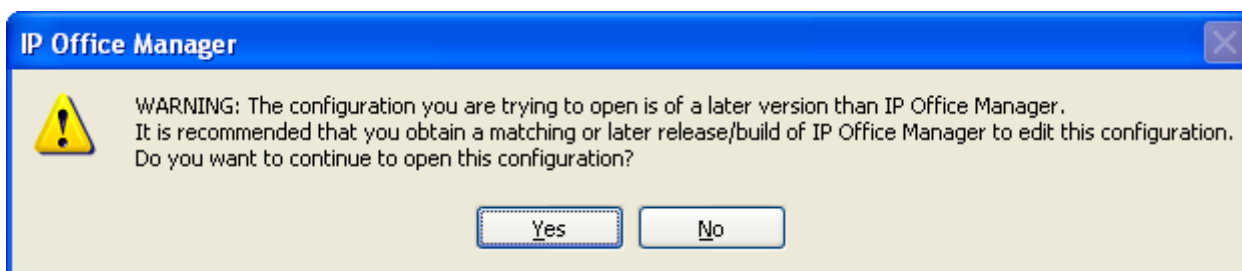
Earlier releases of IP Office 9.0 Manager are not compatible with systems running this release. Before upgrading an IP Office system to the 9.0.3.0.941 release, the Administration suite must also be upgraded. The following message will be displayed if attempting to access a system running the 9.0.3.0.941 release with an earlier version of Manager:
