IP Office Technical Bulletin

Bulletin No: 173
Release Date: 01 December 2014
Region: Global

General Availability (GA) - IP Office Release 9.0 Service Pack 5

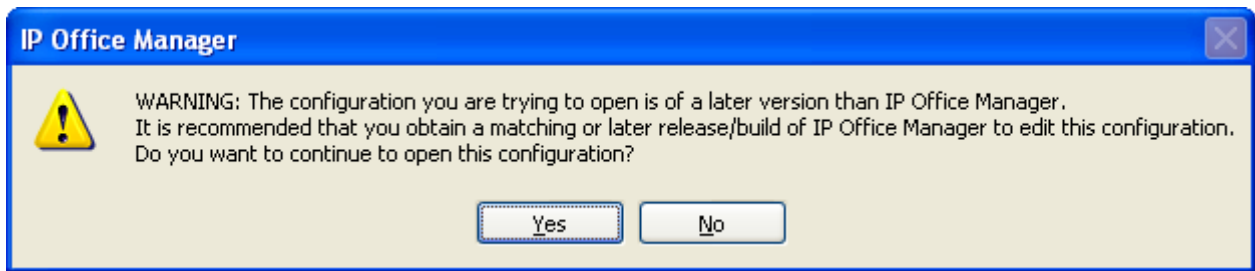
Earlier releases of IP Office 9.0 Manager are not compatible with systems running this release. Before upgrading an IP Office system to the 9.0.5.0.972 release, the Administration suite must also be upgraded. The following message will be displayed if

attempting to access a system running the 9.0.5.0.972 release with an earlier version of Manager:

The IP Office Administration installer will detect previous installed versions and upgrade automatically. If a version earlier than 4.2 is installed, this must first be uninstalled before installing 9.0.5.0.972. It is not necessary to restart the PC after upgrading unless instructed to do so.

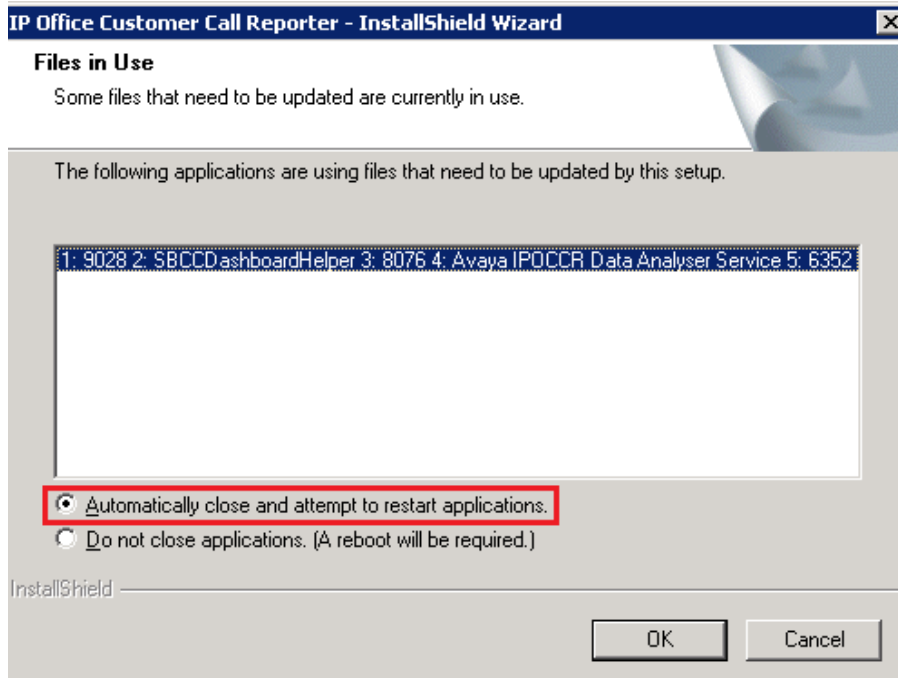
The following dialog box may be displayed during an upgrade to this release:

If this is displayed during the upgrade ensure that the highlighted option is selected and then click “OK”. The upgrade will then continue as normal.
