IP Office Technical Bulletin

Bulletin No: 205
Release Date: 2nd June 2017
Region: Global

General Availability (GA) - IP Office Release 9.1 Service Pack 11

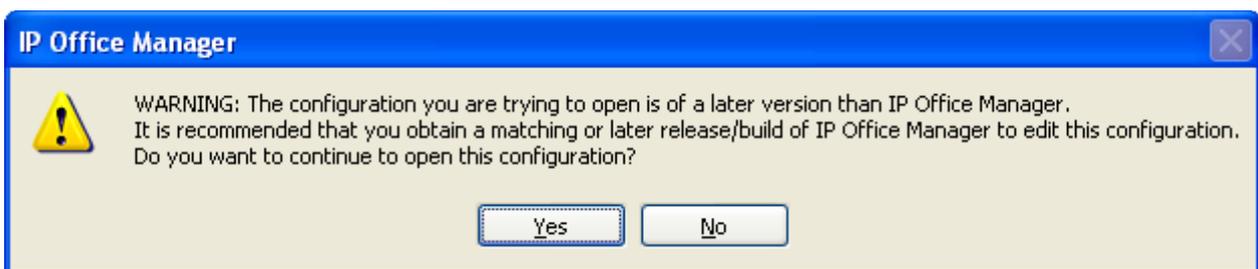
Earlier releases of IP Office 9.1 Manager are not compatible with systems running this release. Before upgrading an IP Office system to the 9.1.11.0.202 release, the Administration suite must also be upgraded. The following message will be displayed if attempting to access a system running the 9.1.11.0.202 release with an earlier version of Manager:

The IP Office Administration installer will detect previous installed versions and upgrade automatically. If a version earlier than 9.0 is installed, this must first be uninstalled before installing 9.1.11.0.202. It is not necessary to restart the PC after upgrading unless instructed to do so.
