IP Office Technical Bulletin

Bulletin No: 207
Release Date: 11th September 2017
Region: Global

General Availability (GA) - IP Office Release 9.1 Service Pack 12

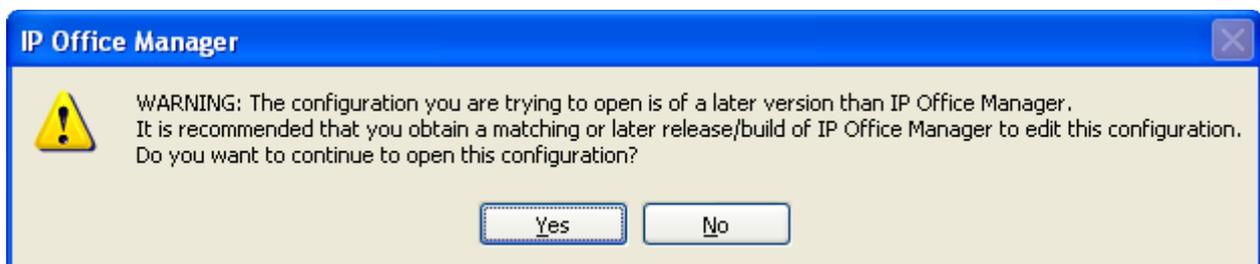
Earlier releases of IP Office 9.1 Manager are not compatible with systems running this release. Before upgrading an IP Office system to the 9.1.12.0.212 release, the Administration suite must also be upgraded. The following message will be displayed if attempting to access a system running the 9.1.12.0.212 release with an earlier version of Manager:

The IP Office Administration installer will detect previous installed versions and upgrade automatically. If a version earlier than 9.0 is installed, this must first be uninstalled before installing 9.1.12.0.212. It is not necessary to restart the PC after upgrading unless instructed to do so.
