IP Office Technical Bulletin

Bulletin No: 198
Release Date: 13th December 2016
Region: Global

General Availability (GA) - IP Office Release 10.0 Service Pack 2

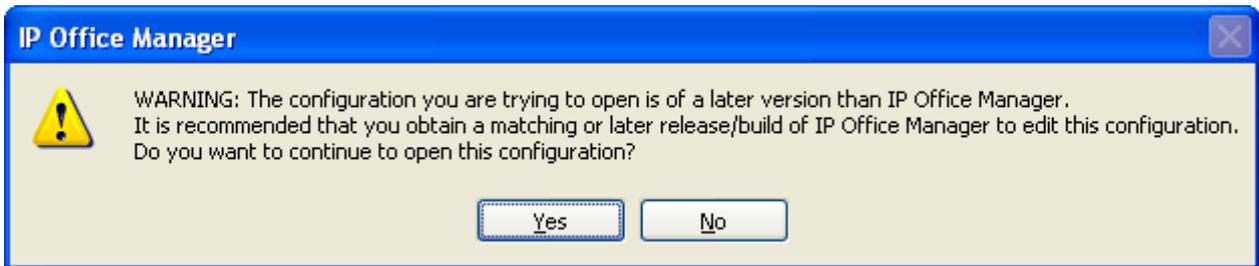
The previous GA release of IP Office 10.0 Manager is not compatible with systems running this release. Before upgrading an IP Office system to the 10.0.0.2.0.10 release, the Administration suite must also be upgraded. The following message will be displayed if attempting to access a system running the 10.0.0.2.0.10 release with an earlier version of Manager:

The IP Office Administration installer will detect previous installed versions and upgrade automatically. If a version earlier than 9.0 is installed, this must first be uninstalled before installing 10.0.0.2.0.10. It is not necessary to restart the PC after upgrading unless instructed to do so.
