IP Office Technical Bulletin

Bulletin No: 202
Release Date: 6th March 2017
Region: Global

General Availability (GA) - IP Office Release 10.0 Service Pack 3

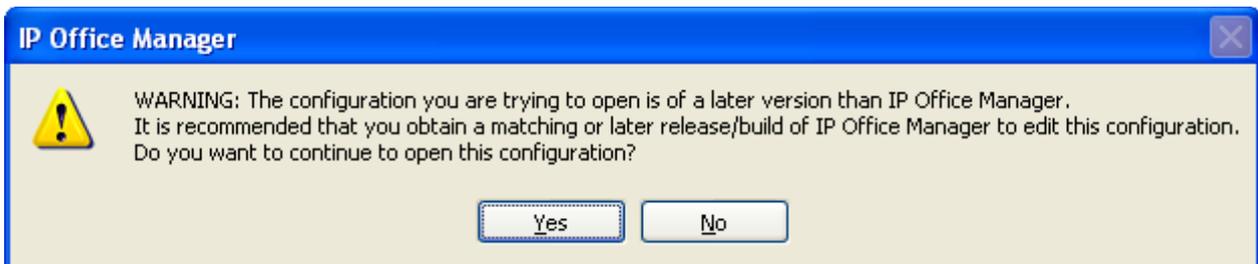
The previous GA release of IP Office 10.0 Manager is not compatible with systems running this release. Before upgrading an IP Office system to the 10.0.0.3.0.5 release, the Administration suite must also be upgraded. The following message will be displayed if attempting to access a system running the 10.0.0.3.0.5 release with an earlier version of Manager:

The IP Office Administration installer will detect previous installed versions and upgrade automatically. If a version earlier than 9.0 is installed, this must first be

uninstalled before installing 10.0.0.3.0.5. It is not necessary to restart the PC after upgrading unless instructed to do so.
