IP Office Technical Bulletin

Bulletin No: 171
Release Date: 26 September 2014
Region: Global

General Availability (GA) - IP Office Release 9.0 Service Pack 4

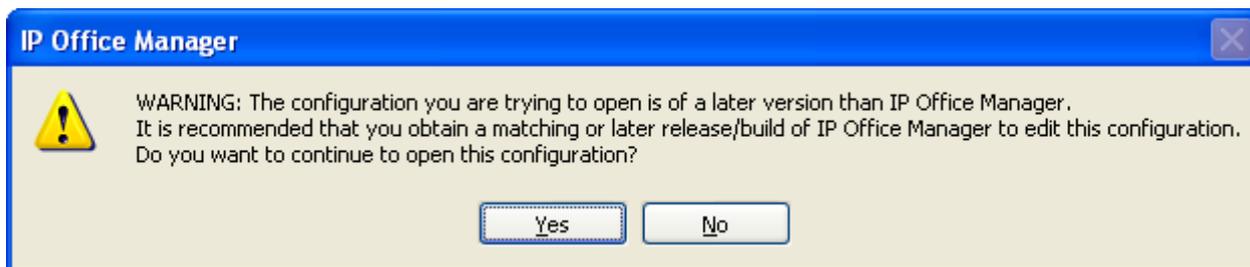
Earlier releases of IP Office 9.0 Manager are not compatible with systems running this release. Before upgrading an IP Office system to the 9.0.4.0.965 release, the Administration suite must also be upgraded. The following message will be displayed if

attempting to access a system running the 9.0.4.0.965 release with an earlier version of Manager:

The IP Office Administration installer will detect previous installed versions and upgrade automatically. If a version earlier than 4.2 is installed, this must first be uninstalled before installing 9.0.4.0.965. It is not necessary to restart the PC after upgrading unless instructed to do so.

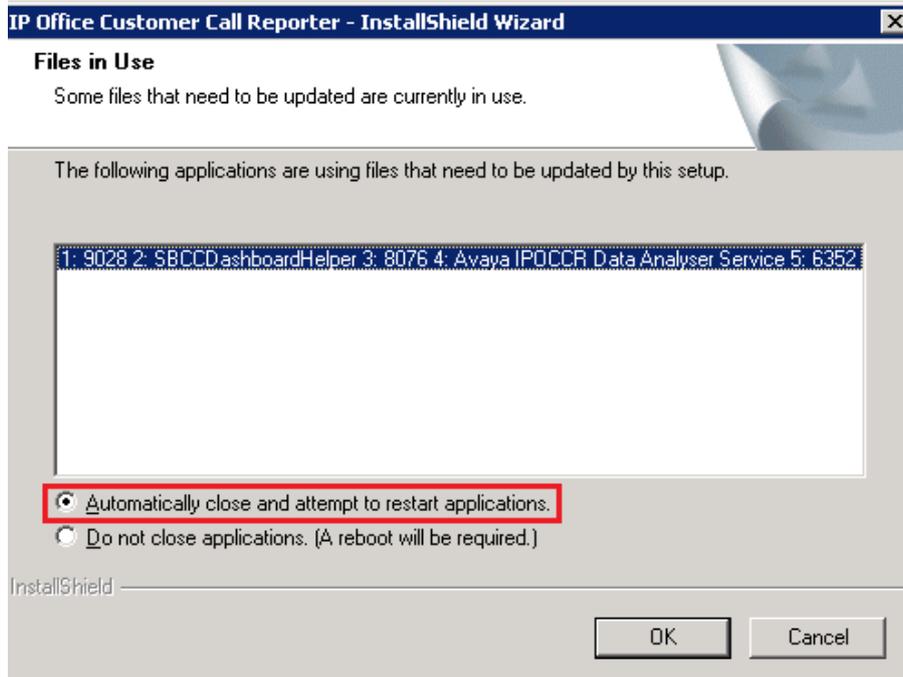
The following dialog box may be displayed during an upgrade to this release:

If this is displayed during the upgrade ensure that the highlighted option is selected and then click “OK”. The upgrade will then continue as normal.
