WEC8500/WEC8050 (APC)

Maintenance Manual

This manual describes how to identify the cause of failures which occur in the Access Point Controller (APC) system and troubleshoot them.

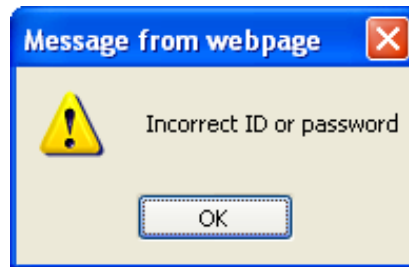
Figure 2. Web UI Login Error Window

When attempting to log in at the Web UI, login fails and the 'Incorrect ID or password' error message is shown.
